# Study of Ideal Dry Pipe Valve

A STUDY  
of  
IDEAL DRY PIPE VALVE

A T H E S I S

BACHELOR OF SCIENCE IN FIRE PROTECTION ENGINEERING

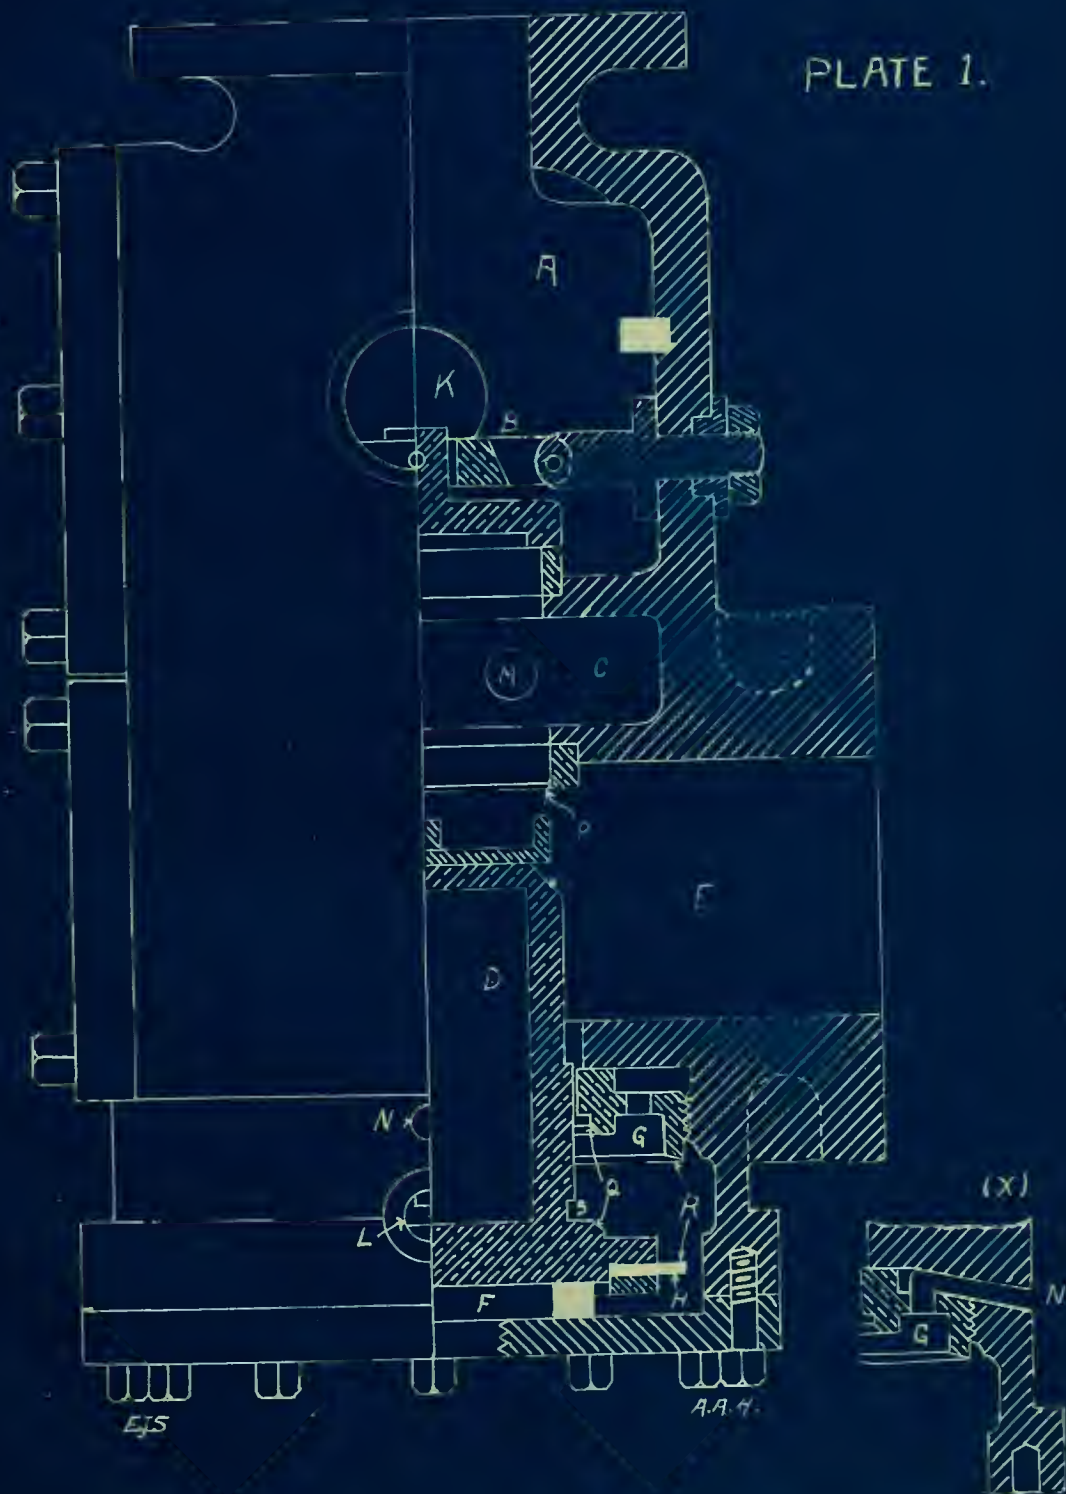
PLATE 1.

The blue print on page ( 9 ) shows the first pattern of the valve in cross section. It is divided into five (5) chambers, - A, C, E, F and G. A and F are connected by a  $3/4$ " pipe and are under air pressure; chamber E is under water pressure, and chambers C and G are connected by a  $1/2$ " pipe which is vented to the atmosphere. The connection between C and G is not altogether plain on account of the blue print not showing any direct connection between N and G. As shown, G apparently opens through a  $3/8$ " hole into a channel, which is vented through N. However, this is better shown in X, which is a cross section through N, and shows that the opening above G is not a channel. In the body of the valve are two moving parts, - clap valve B which separates A and C, and movable member D, which is a solid brass shell weighing 20# 13.5 oz. when empty and 23# 14.5 oz. when full. On this brass valve are two rigid faces (P) - (Q), and one flexible rubber face (H). The two rigid faces are ground to fit the brass seats (P-Q) after the latter are in position in the cast iron body, and form the shut-off against the water pressure when the valve is set.

D is held against its seats, any pressure turned into A is transmitted to chamber F through the 3/4" pipe connecting A to F, and acts against the bottom of the valve holding the faces against their seats. From the blue print it can be seen that pressure in F will act on an area equivalent to the area of a circle of the same diameter as the largest seat (R), and that this pressure acts against the weight of the valve added to the pressures acting on the annular rings (R. Q.) and (Q.P), and on the circle having the same diameter as the seat (P). As the chambers (C) and (G), which the seats (P) (Q) and (R) close, are connected together and vented to the atmosphere, we <sup>have</sup> the annular ring (P) (Q) remaining for the pressure in (E) to act against, and since the area of this annular ring is smaller than the area on which the pressure in (F) acts, it follows that any pressure in (F) will hold the valve against a higher pressure in (E), i.e., the valve works on the differential principle.

The results of the tests made in 1903 and early in 1904 show that there is something radically wrong with the first pattern. In "firing" with water pressures around 50#, the movable member apparently does not drop to the end of its travel, but merely opens a short distance and is immediately slammed back on its seats. When the amount of flow through the riser was small, the pressure in (A) slowly became equal to that in (E), and when the discharge from the riser was quickly opened a heavy water hammer was noted. Numerous theories could be brought forward to account for this action, but probably one as satisfactory as any is this:- When the valve is near the "firing" point, that is, when the total pressure on the lower part of (D) in chamber (F) approaches the total pressure acting downward on (D) in chambers (C) (E) and (G), water begins to creep past seats (P) and (Q), and, as the vent for chambers (C) and (G) is small, the pressure accumulates in both chambers, but more rapidly in (G) than in (C), on account of the larger diameter of the seat (Q). Now this pressure in (G) passes seat (R) and accumulates in (F), with the result that (D) is prevented from falling. until the pressures in the different chambers are equalized, which, when the passage from (F) to (A) is restricted in any way, can only occur slowly, or not at all when the passage is restricted and the discharge opening from (A') is large. However, if the pressures do become equalized, (D) does apparently drop to the end of its travel, otherwise, there could be no heavy water hammer when the discharge from (A)

is quickly increased. It would seem that the heavy flow from (E) to (A), when the discharge from (A) is opened wide, creates a suction which lifts (D) quickly and slams it against its seats with the result that we have a return to the point where the accumulation of pressure in (F) holds (D). In order to prove or refute this theory, it was necessary to make a series of tests on both patterns, introducing as far as possible conditions such as could easily occur in the field.

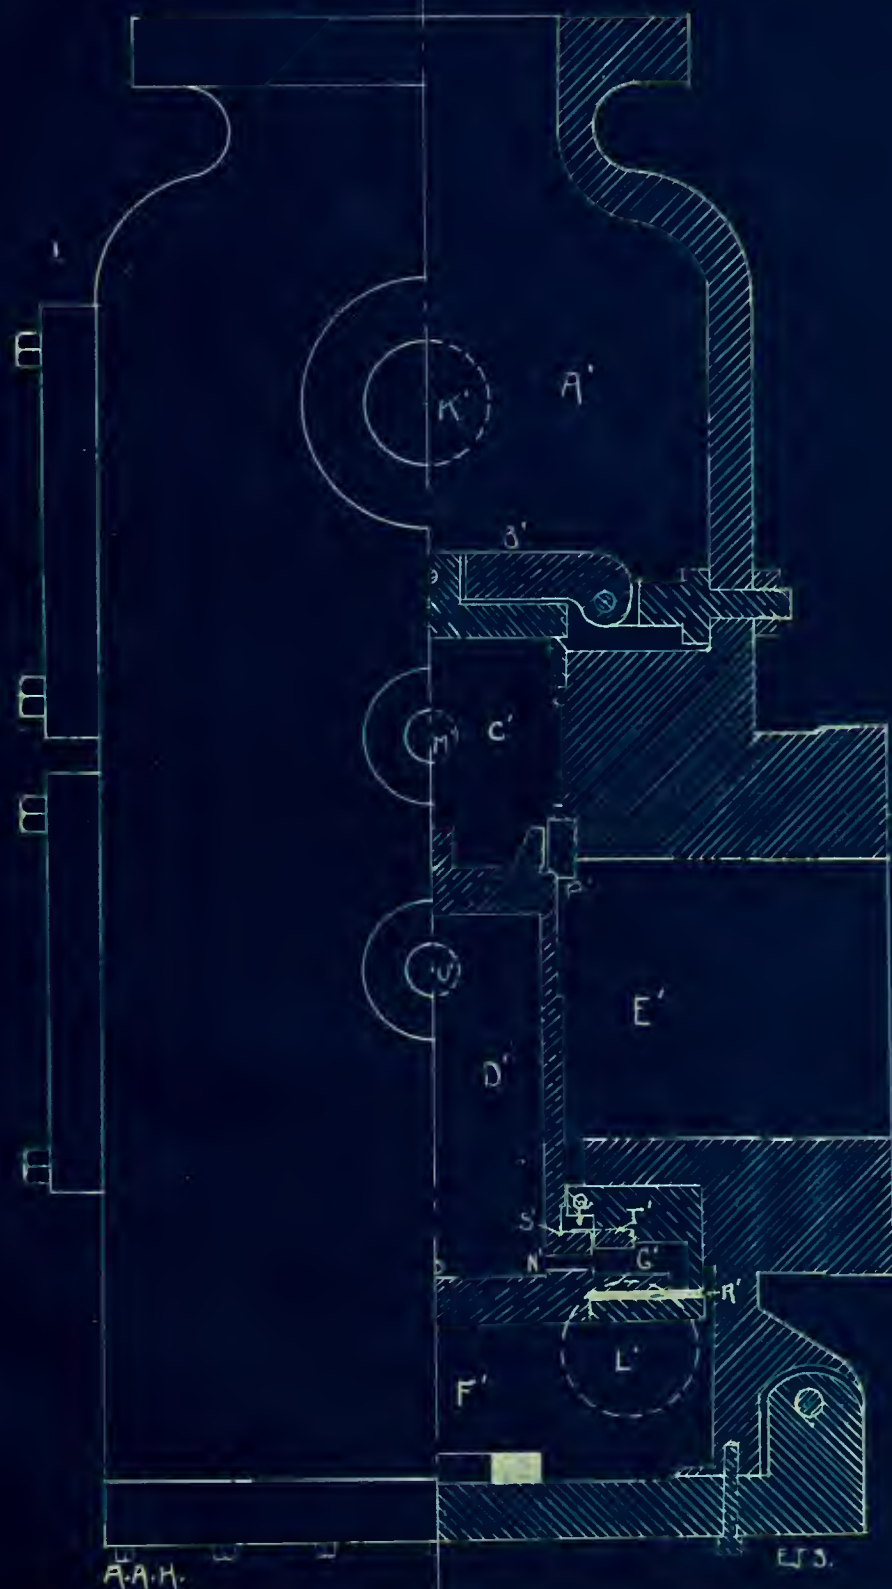
PLATE 2.

The second pattern submitted works on the same principle, but differs in construction. Instead of having two rigid seats, this pattern has the lower seat (Q) replaced by a brass diaphragm, and has the chambers connected differently.

(A') and (B') are connected by a 2" pipe, and (C') connects through the body of the movable member, with (G') and is vented to the atmosphere. The dimensions of the two valves differ somewhat, but not in a way to materially affect the operation. On page (24) is given a dimensional comparison of the two valves.

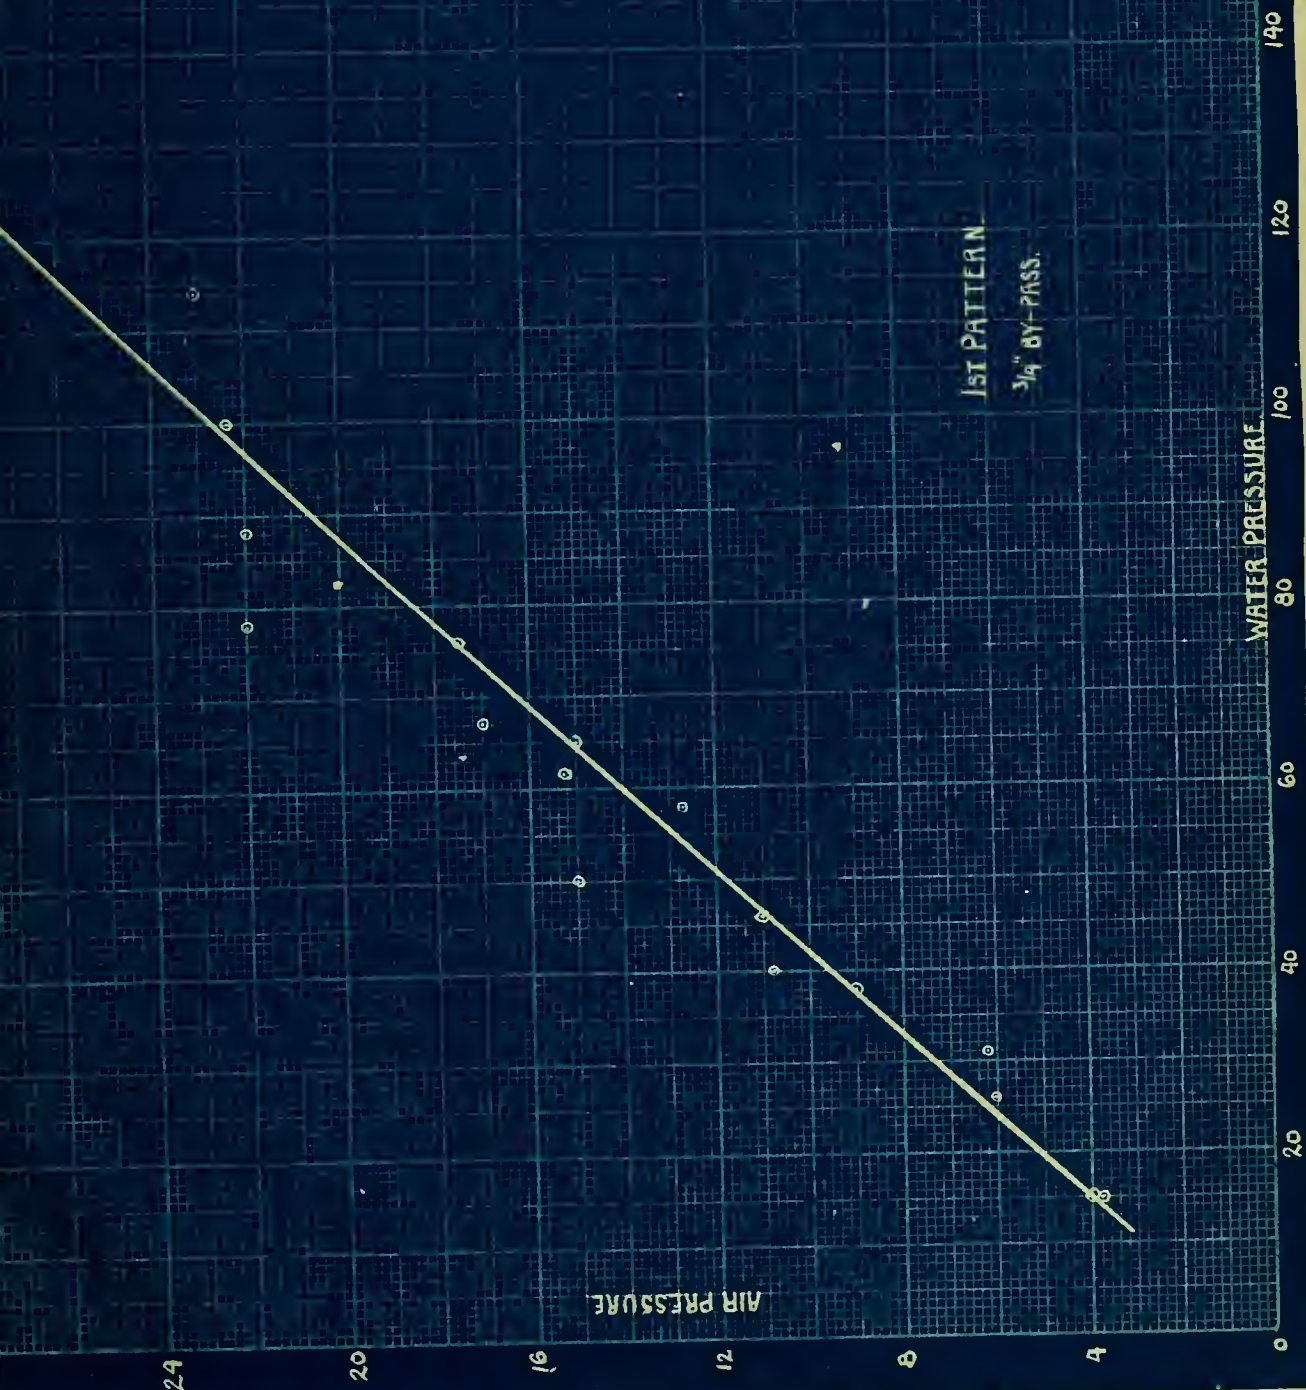
# PLATE 6

FIRST PATTERN. (3/4" By-Pass).

Water hammer occurred at 38#, 58#, 67#, 87#, 113.8# water pressure. At all other pressures above 25#, movable member found jammed. Time necessary for system to equalize varied from 50 to 70 secs. Water hammer was also produced on suddenly opening discharge valve at those pressures where water hammer occurred on "firing". At the pressures which the movable member jammed, no water hammer resulted on suddenly opening the discharge valve. No doubt the jamming of movable member on "firing" prevented this, as will be seen later on. The seats leaked badly at all pressures. On account of the tendency of the movable member to stick on "firing", a series of tests were made with movable member not set but resting on bottom of chamber (F). The water pressure was raised to 80#. The discharge valve was suddenly opened. The object of this series of tests was to pick up movable member and produce water hammer.

Water pressure. 78#,- opening discharge valve violent hammer resulted; 68#, same result; 62#, no hammer, but valve again jammed; 53#, violent hammer again resulted; 42#, no hammer, nor was movable member stuck.

Drop in water pressure over valve noted from gauge readings on air and water side found to be about 15# in all cases. As a rule, movable member was found jammed about 1/4" above rubber ring in chamber (F). At 76.9# water pressure movable member had turned a quarter of one revolution and was so tightly jammed that considerable force was necessary to loosen it. In most cases when movable member jammed it could be loosened by use of hand alone. Another curious

water hammer in system, as shown by violent fluctuation of gauge needles. The probable reason for water hammer is the accumulation of pressure in chamber (F). Water hammer starts in at about 40#, never below this pressure. At the higher pressure the hammer is so violent as to injure the seats, which partly accounts for their poor condition.

The trip points are fairly uniform. The curve drawn through these points is very much steeper than the theoretical curve; also very much steeper than the curve obtained from the tests made at the Underwriters' Laboratories in September, 1903 and January, 1904.

The increase in air pressure necessary to hold movable member against water pressure is due to corrosion and wear of seats. The violent water hammer to which the valve has been subjected during the 3 years test at the laboratory has injured the seats to a marked extent, and thus a higher air pressure is necessary to make the seats tight.

At the end of this test, the 3/4" by-pass was taken apart, and on examination of piping of by-pass it was found to be badly corroded. Actual diameter of pipe measured 9/16" at the union, 3/16" less than original diameter of pipe. Thus the 3/4" by-pass is really a 1/2" by-pass, and is later on compared with the second pattern with a 1/2" by-pass.

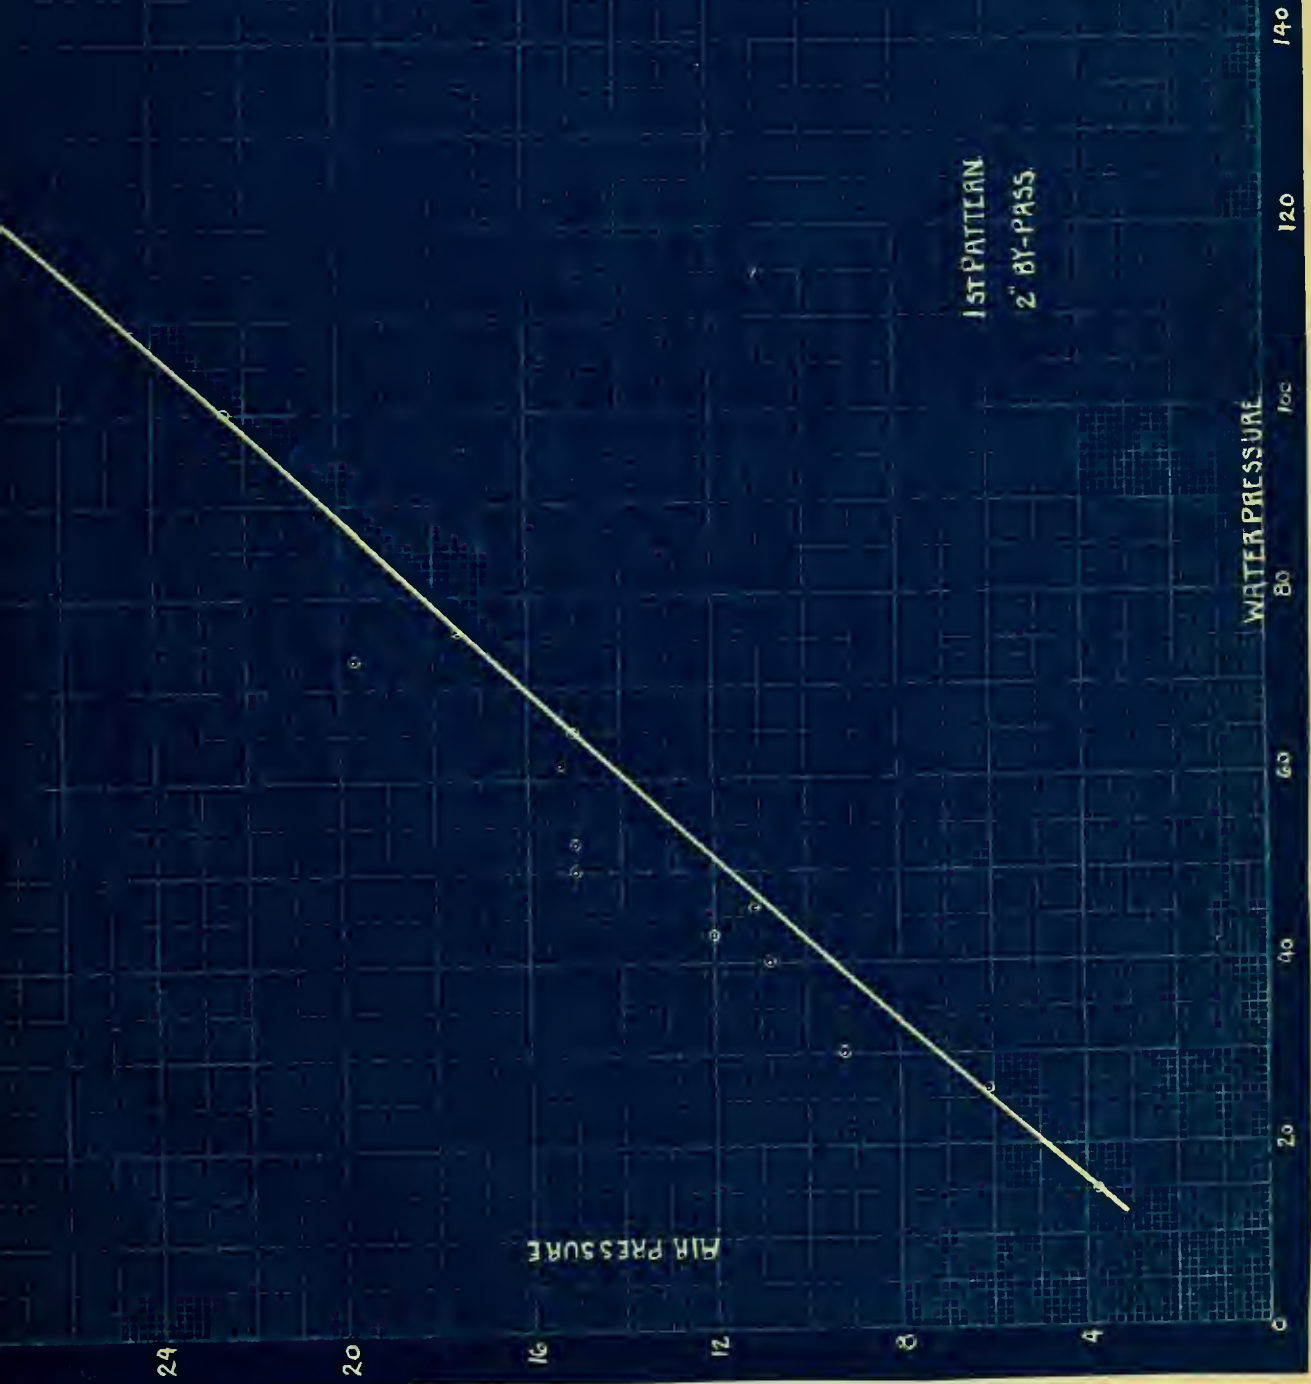
# PLATE 7

FIRST PATTERN (2" by-pass).

As stated before, the 2" by-pass in this test was inserted in the bottom plate of the valve. In "firing" the valve, the 4" gate was slightly opened until the valve fired, and as soon as the pressure on both sides of the valve equalized, which it did in less than 12 seconds, the gate was quickly opened. No water hammer was obtained either before or after the discharge was fully opened. In setting the valve the movable member jams easily, i.e., the guides stick in the opening through which they pass. When high water pressure is used it is necessary to use care in turning the pressure on the valve unless large air pressure is carried. In one instance when a water pressure of 100 lbs. was rapidly turned into the valve with 25 lbs. air pressure on the system, the valve immediately "fired". When the water pressure is turned on slowly, this trouble is eliminated. No continuous notes were taken of the loss in pressure over the valve, but it was noticed that when the pressure on the water supply was about 40 lbs., the pressure on the sprinkler system was 15 lbs. less.

For five of the "firing points" the mercury gage was used to determine the difference in pressure between A. and F. The gage was connected the same as in the tests on the 3/4" by-pass connection, and in every case the pressure was greater in the lower chamber. As shown in the data, the pressure in F. exceeds that in A. from 9 lbs. to 20 lbs. before opening the discharge valve, and from 4 lbs. to 10 lbs. after opening. In order to determine whether it was possible to pick up the

movable member when it was positively at the end of its travel, the face plate in the lower chamber was taken off and the movable member placed squarely on the bottom. The plate was then replaced and the water pressure turned on slowly, so that the pressure in the system rises gradually without any chance for the movable member being picked up. Then with 87 lbs. pressure on the system, the discharge was opened wide and the pressure lowered to 30 lbs. No water hammer resulted and the flow was unrestricted. The pressure in the lower chamber was about 10 lbs. more than in the upper.

During all these tests, when the valve was set, a large amount of leakage from the intermediate chamber was noted.

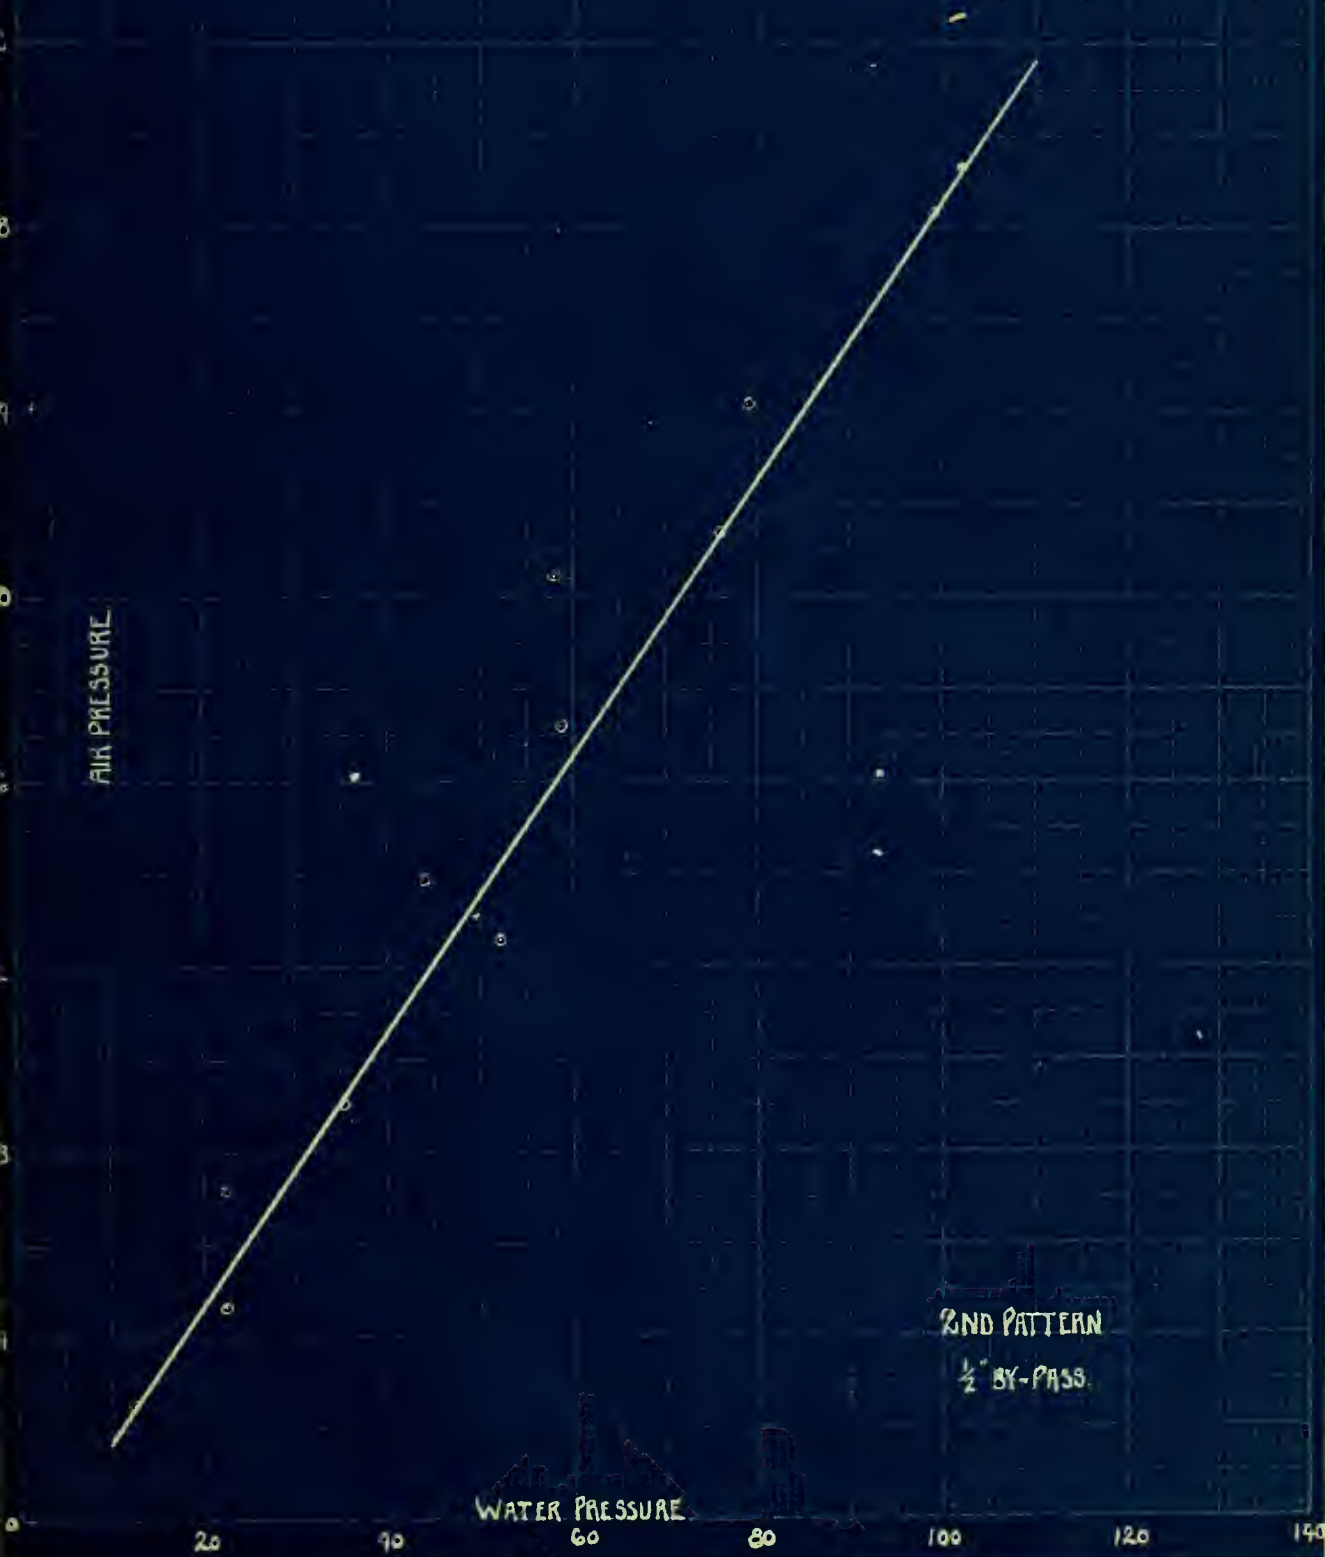
PLATE 8

SECOND PATTERN. (1/2" By-Pass).

With this size of by-pass we have a condition which is nearly parallel with that under which the first pattern was tested when the 3/4" by-pass was used (caused by the corrosion in the 3/4" pipe used on the first pattern). In all, twelve tests were made with this size of by-pass, and the results show that this pattern has the same objectionable features as the first pattern, when the passage between the upper and lower chamber is restricted. The action of the valve was very erratic, for in some instances it was not possible to get water hammer when the conditions were such that this could be expected. In all instances of this kind the movable member was found jammed against its guides. With 14#, 22.2#, 24# water pressure, the valve "fired" without any difficulty, and when the discharge was opened wide no water hammer resulted and pressures equalized quickly. With 37#, 44#, 58.5#, 61.5#, 76#, 79#, 99.5# water pressure, when the valve "fired" a violent chattering occurred. This chattering was unlike the slam which was found in the first pattern, but apparently has the same effect on the seats and also restricts the flow no less. This chattering lasted from 10 to 20 seconds and then ceased, as the pressures on both sides of the valve became nearly equal. From 30 to 40 seconds were required for the pressures to equalize, and when it had done so, the discharge was opened wide. No water hammer of any kind occurred in any one of these seven cases, which may be accounted for by the fact that in each case the movable member was found jammed against its guides, when the face plate was removed.

With 22 $\frac{1}{2}$  water pressure a violent chattering occurred for 20 seconds after the valve "fired", and the pressure on the system equalized in 40 seconds more. The discharge was then opened wide. A "hammer" similar to that found in the first pattern occurred, and was followed by a very violent chattering. With 102.5 $\frac{1}{2}$  water pressure, the chattering lasted for 18 seconds, and pressure equalized in 30 seconds more. The discharge was then opened and the water allowed to escape. The water flowed for 30 seconds when a slam, followed by violent chattering, occurred. The pressure had fallen to 60 $\frac{1}{2}$  before the chattering began.

The mercury gauge was used in all of these tests and in every case the pressure in the lower chamber was found to be greater than that in the upper chamber.

This test demonstrates that the vital point in the "Ideal" dry pipe valve is the by-pass connection between the upper and lower chambers. In the following tests with different sizes of by-pass, the limit is quite clearly shown.

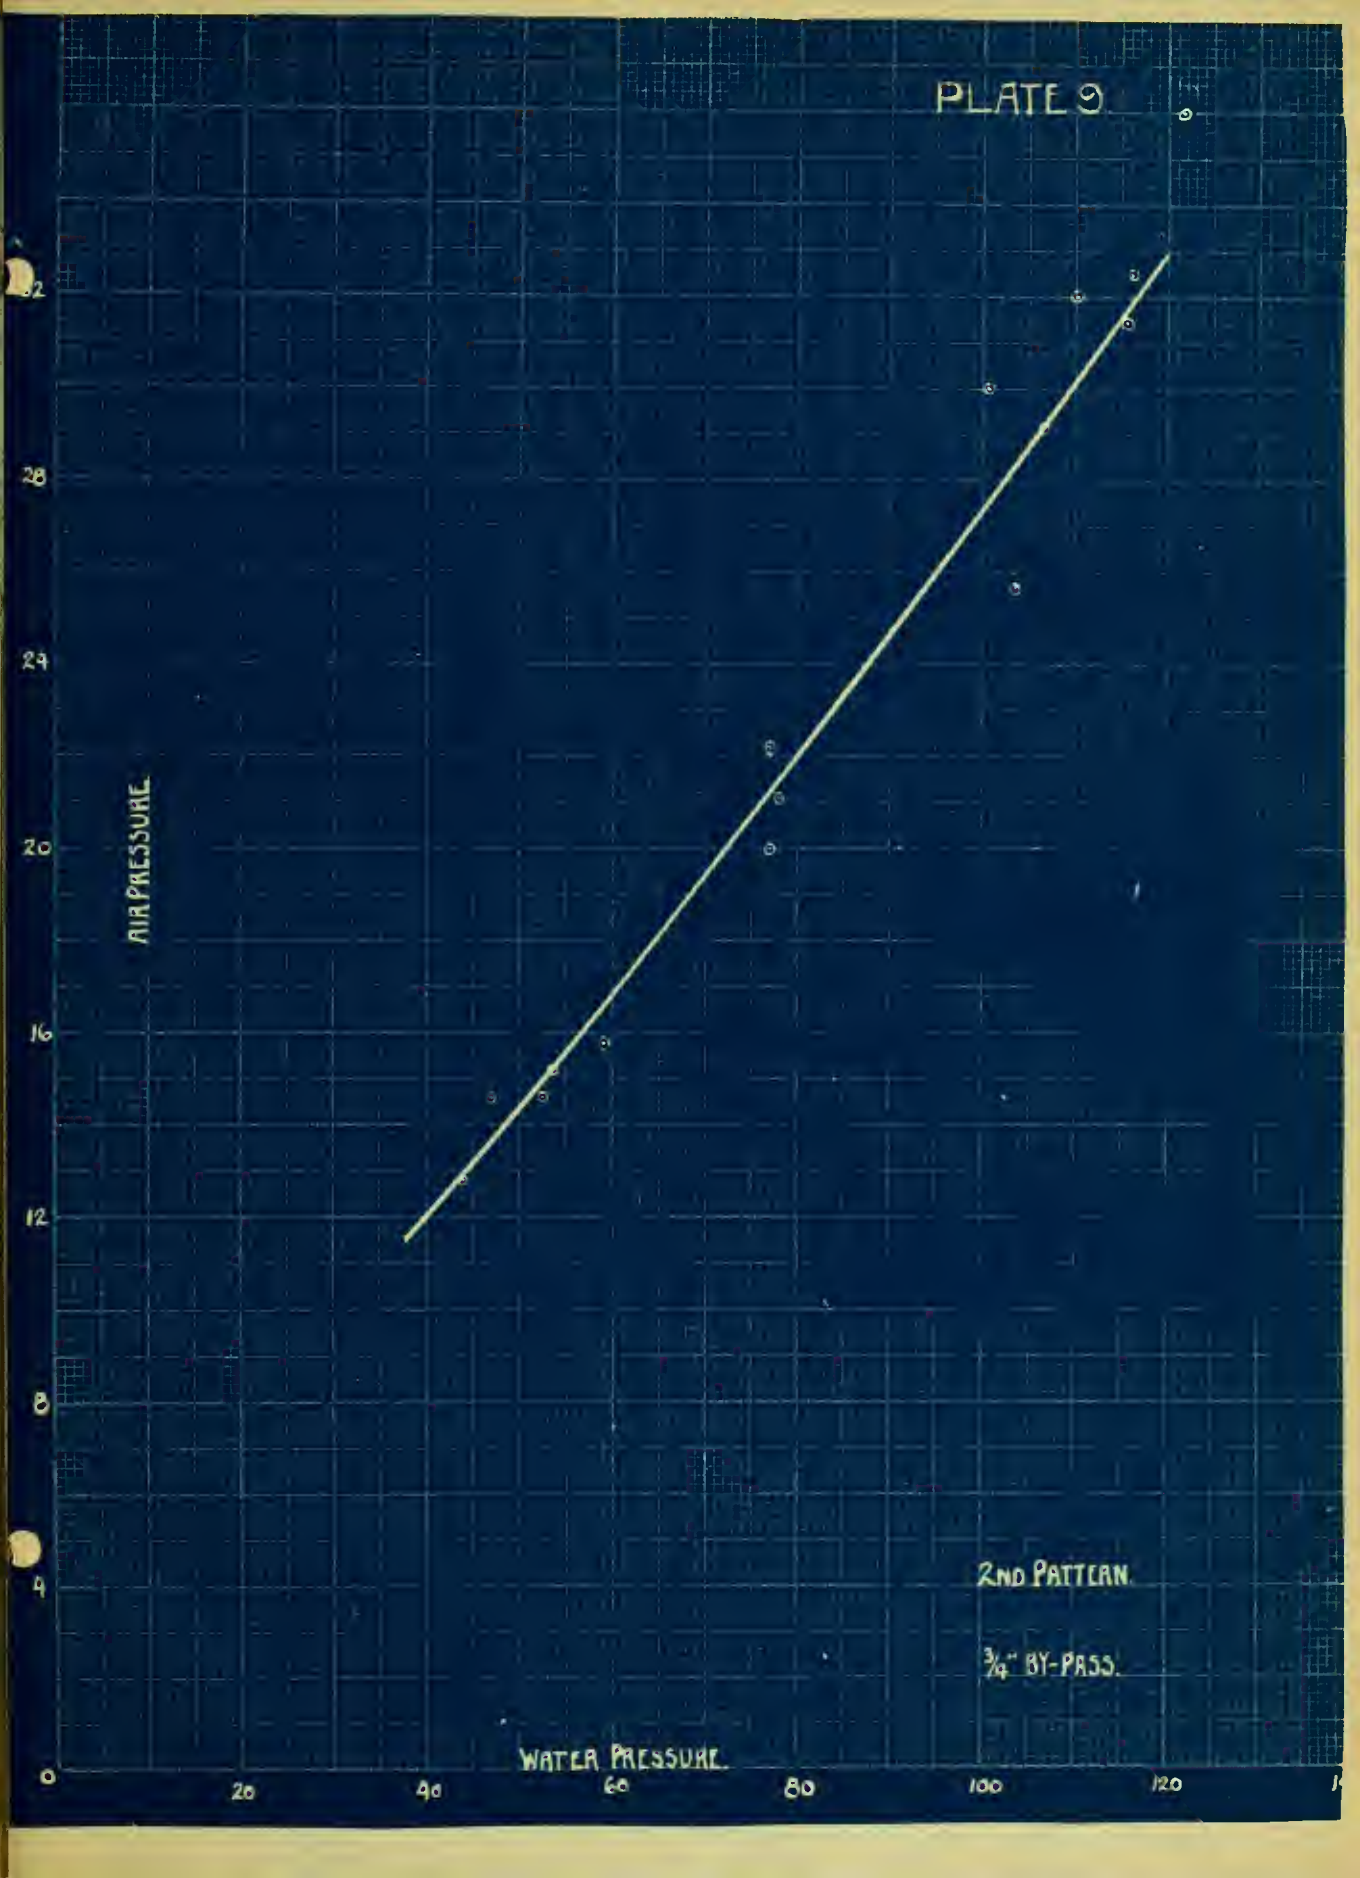
# PLATE 9

Water hammer occurred 77# and 101# of a very violent nature. At 113.5# no water hammer, but movable member found stuck, which accounts for lack of hammer at this high pressure. System equalizes in 10 to 35 seconds. No water hammer observed on opening discharge valve. Mercury gage readings vary from 9.6# to 23.7# on "firing", and from 4.5# to 10.7# on opening discharge valve. From the results of the data it is apparent that the critical point in the size of by-pass at which hammer occurs on suddenly opening discharge valve has passed, but the critical point in regard to hammer on "firing" has not yet been reached. Another interesting fact to be noted is that the movable member in the second pattern is also exhibiting a tendency to stick on "firing". The "firing" points are fairly uniform and the curves through them are not so steep as the 1/2" curve.

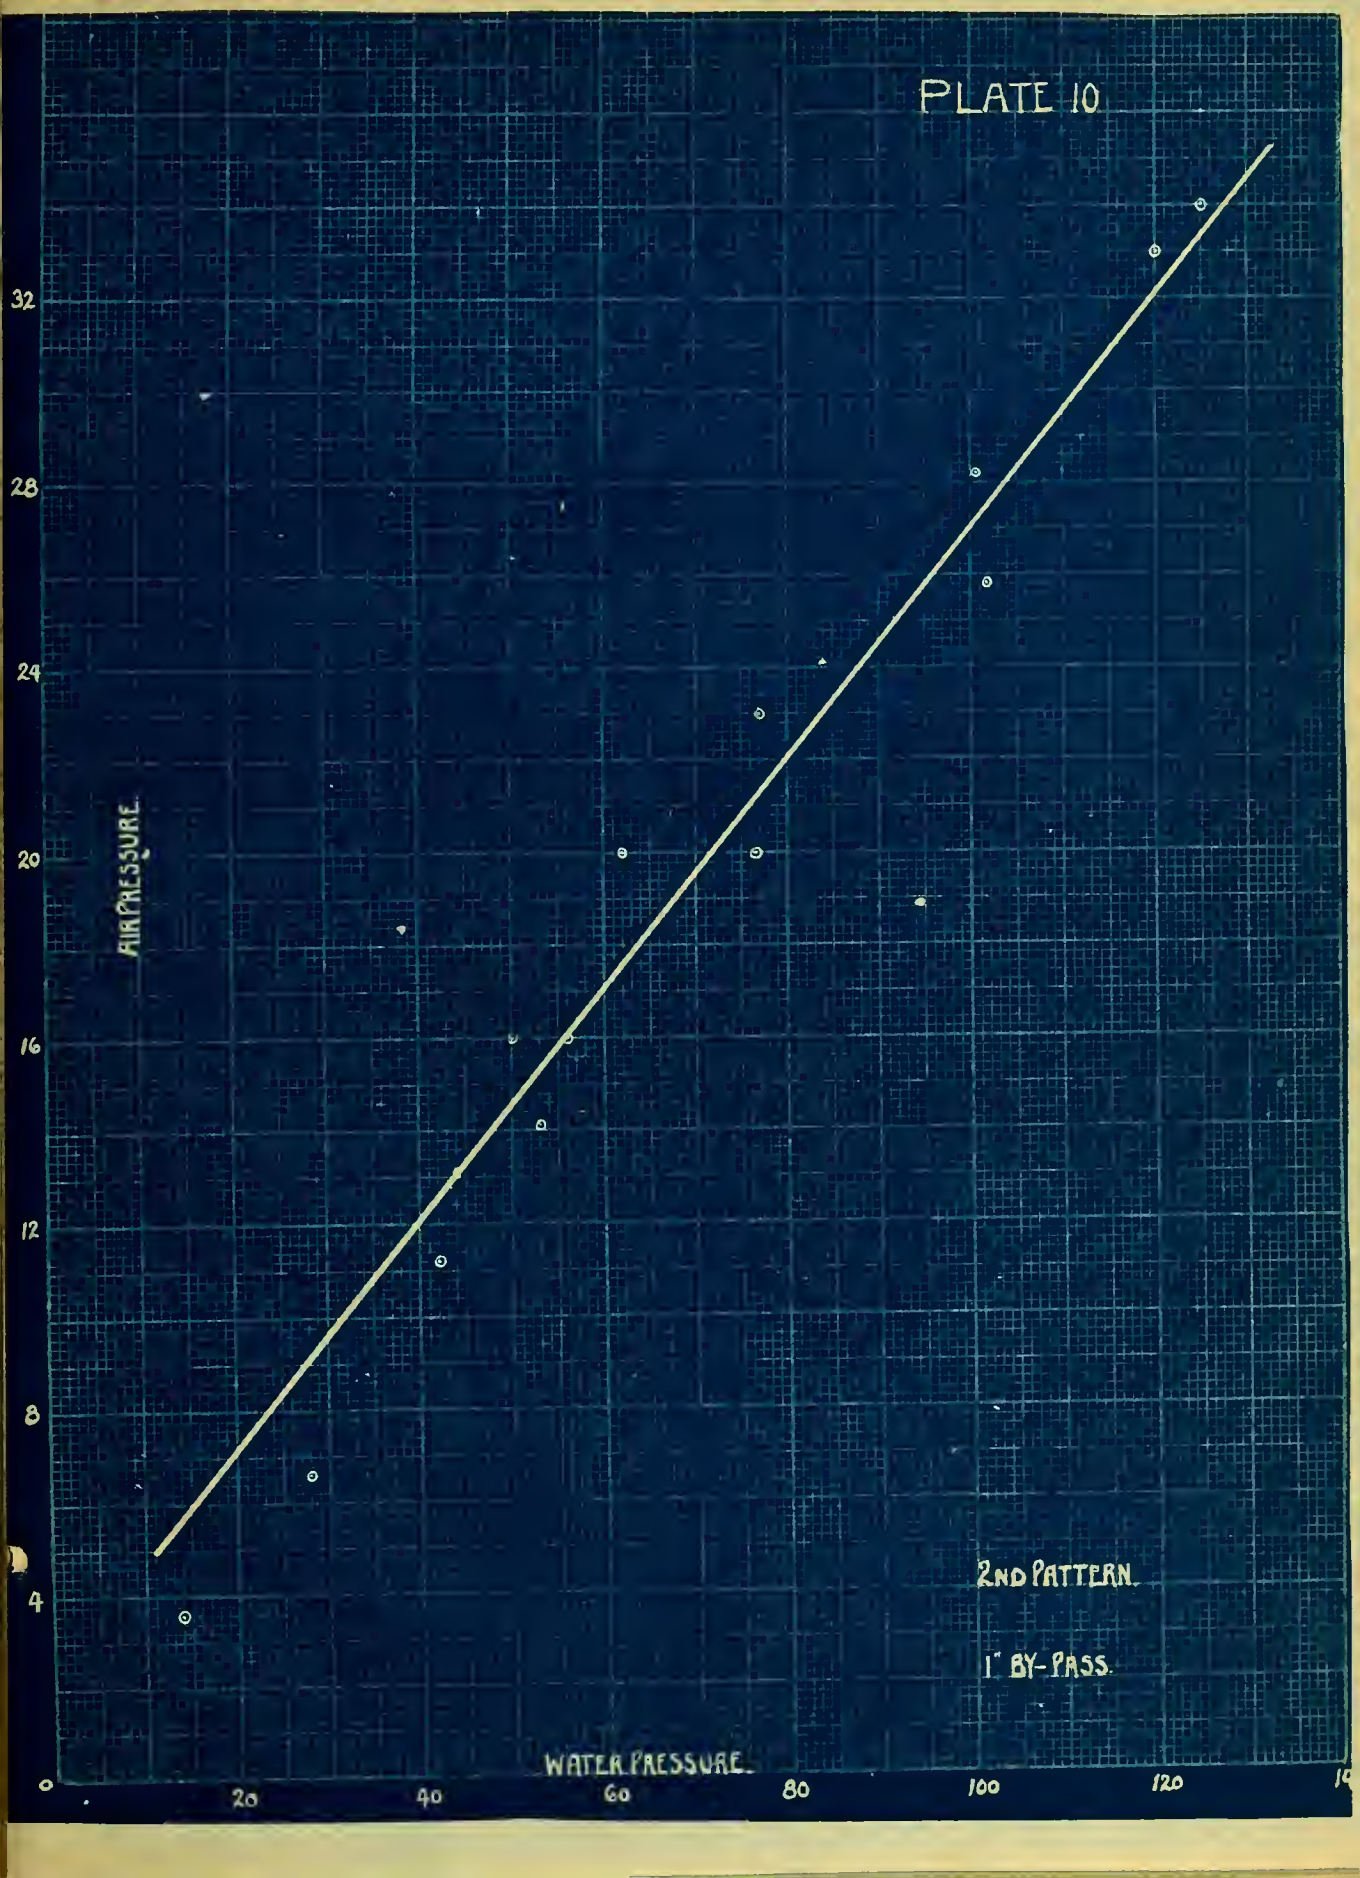
PLATE 10

SECOND PATTERN. (1" By-Pass).

Water hammer at 51.5#, 73.5#, 99#. Valve slammed at 40#. Time to equalize varied from 10 to 30 seconds. No water hammer opening discharge valve. Mercury gauge readings vary from 7.6# to 23.1# on "firing", and 2.8# to 8.6# on opening discharge valve. "Firing" points uniform. Curve not so steep as 3/4" curve.

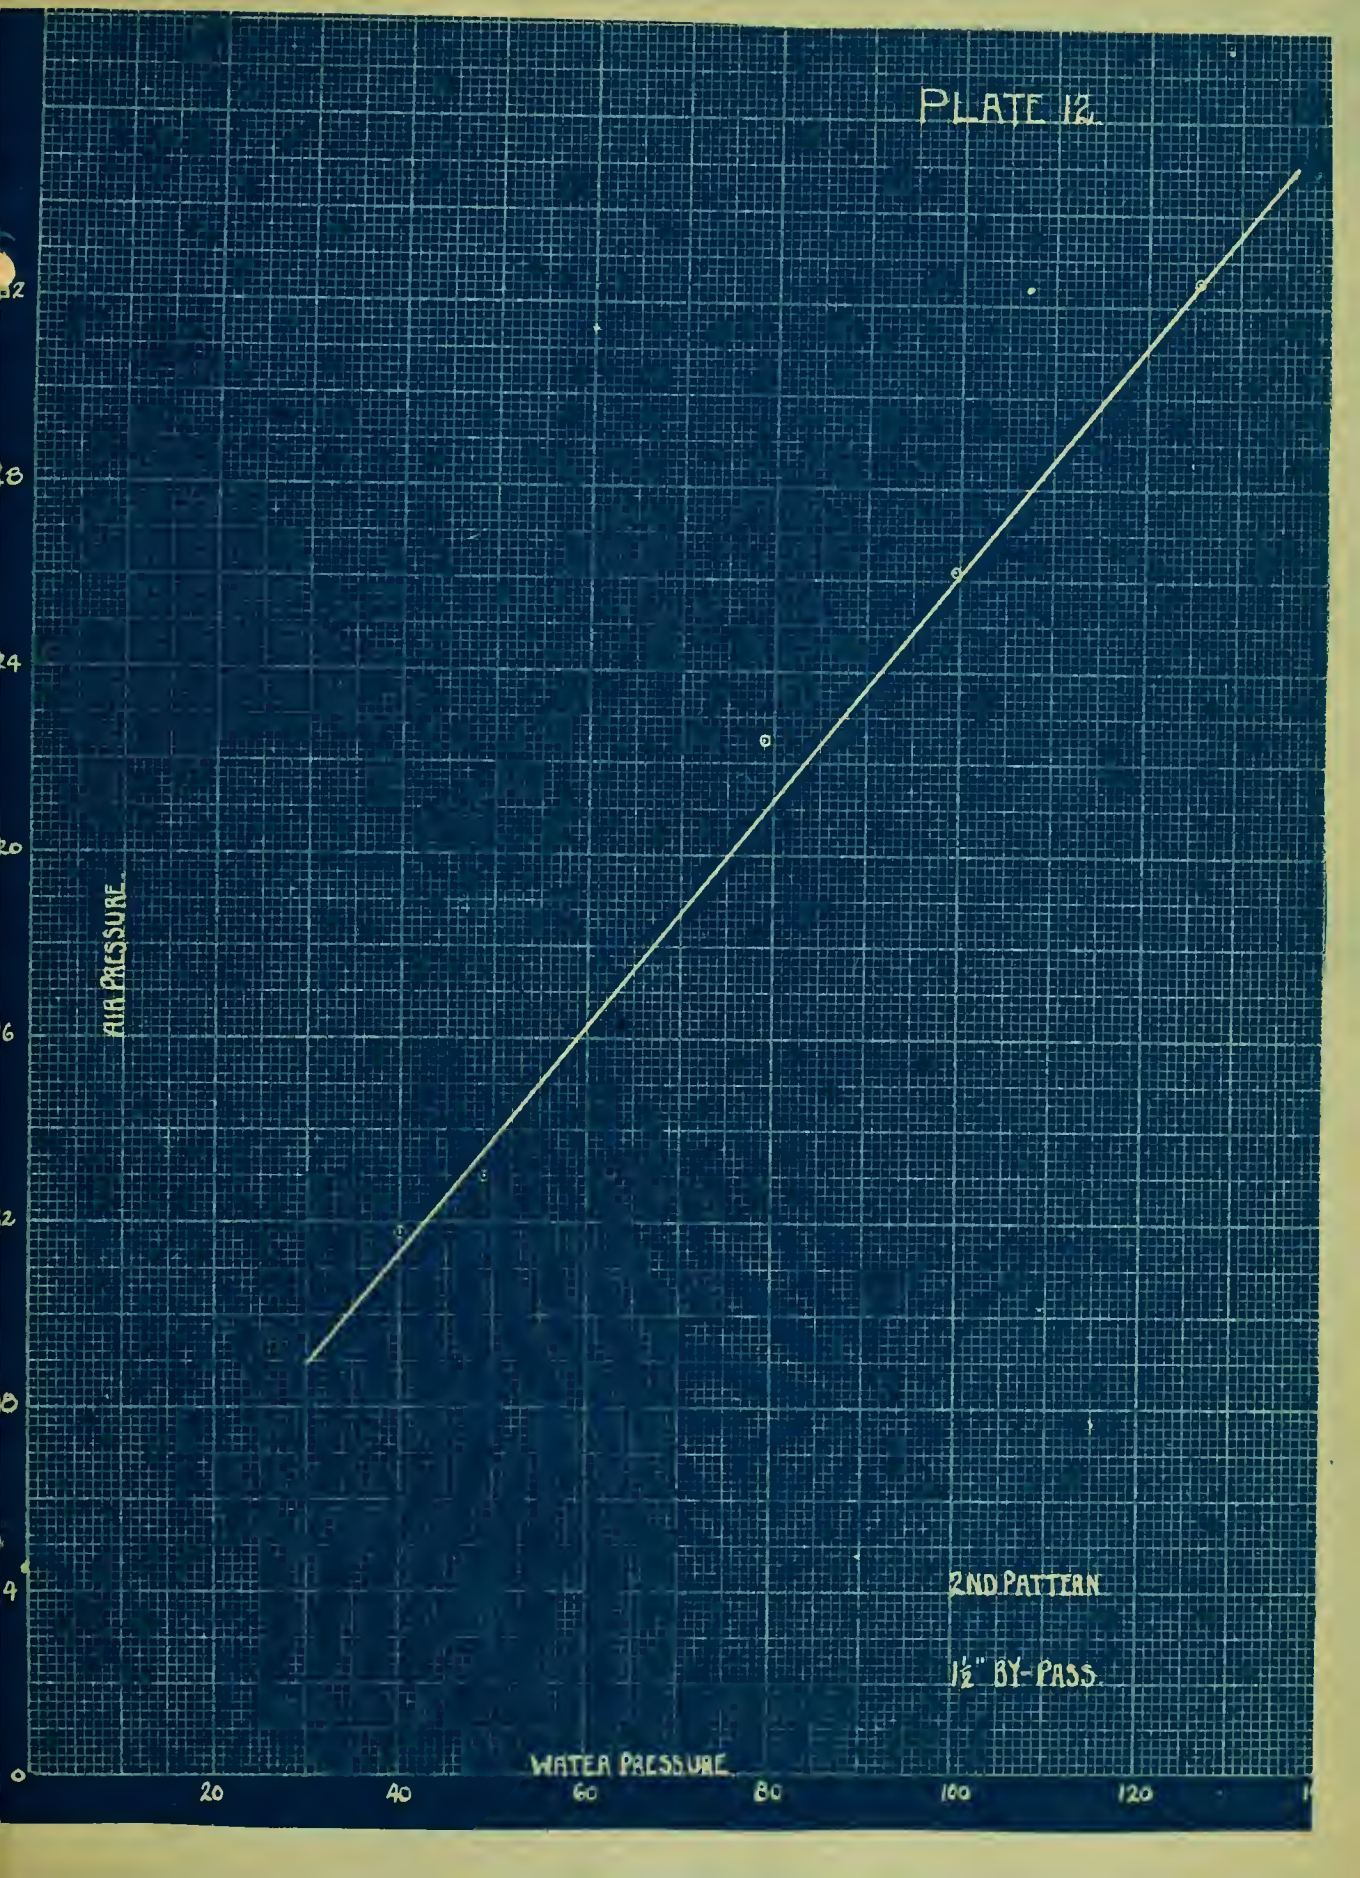
PLATE 12

SECOND PATTERN. ( 1-1/2" by-pass.)

In no instance was water hammer obtained, and the mercury gauge always indicated the larger pressure to be in the lower chamber. This size of by-pass may be considered a safe one, and any addition to this dimension may be considered as a factor of safety.

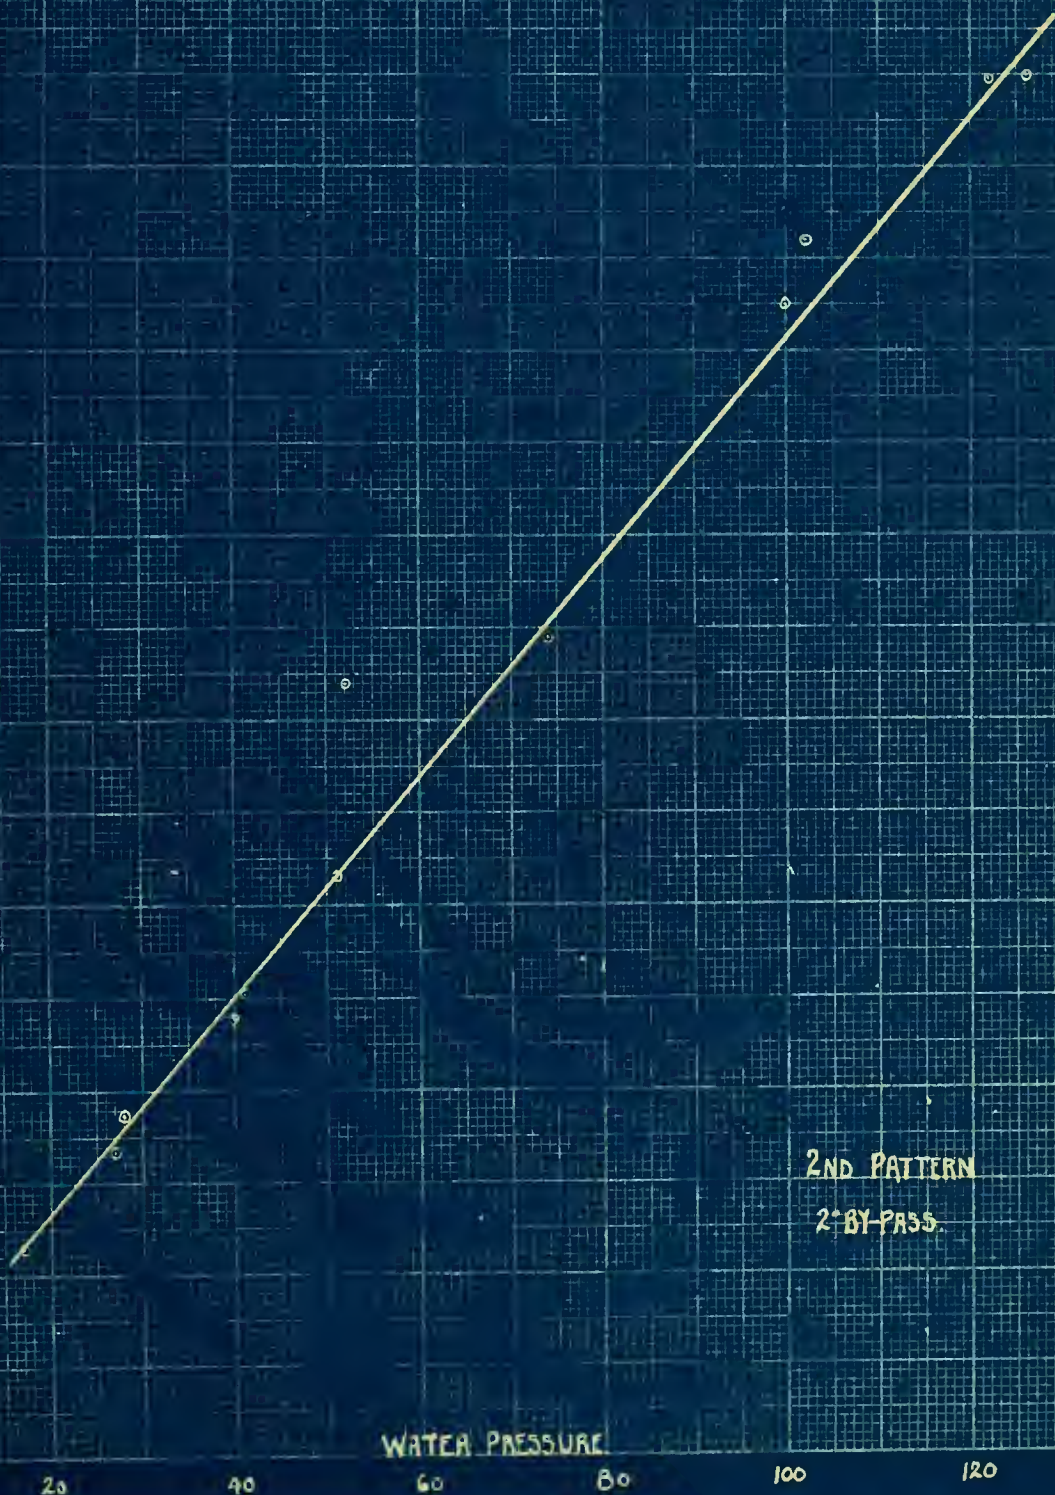
PLATE 13

SECOND PATTERN. (2" By-Pass.)

This is the normal by-pass for this pattern, and the tests will prove whether radical change has been made in the action of the valve. At no pressure was there any evidence of water hammer, and in all cases the pressure on the system equalized quickly ( never longer than 15 seconds!)

The mercury gauge in every instance indicated a larger pressure in the bottom chamber than in the upper chamber. Seemingly, the action of the valve with this size by-pass is very satisfactory.
